Re: Lyons vs. Chevron

Preliminary Investigation Opinion Report

AMT Case #2018-09
Date of Incident May 24, 2007
Time; 15:36
Location: Bayou Lafourche near Leeville, Louisiana
AMT Investigators: Charles R. Clark, Lead Investigator
Bill H. Dobson, CMI, LPI
James "Jay" Barthelme, Graphic Technician
Randy Perkins, Videographer

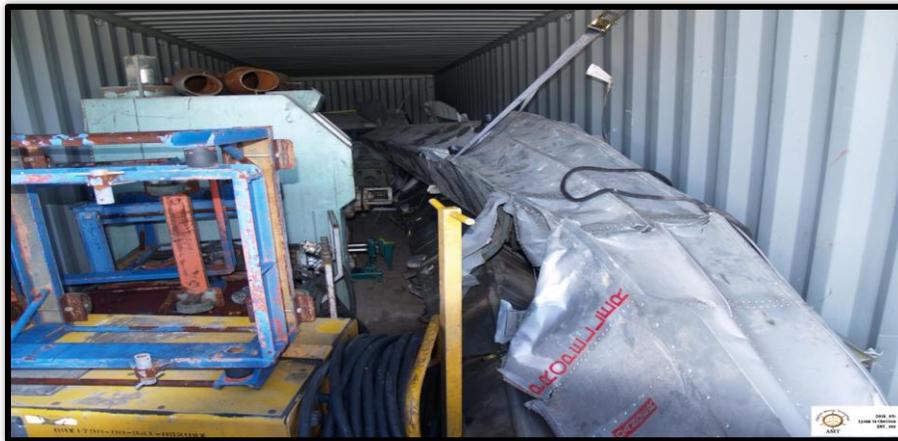
Aircraft storage unit Chevron facility Picayune, MS.

On October 12, 2010, the AMT team traveled to the Chevron Air Operations facility at 96 Runway Road, Picayune, Mississippi and examined the float plane. It should be noted that the plane was stored within a metal container, the wings as well as the floats and propeller had been removed for storage. The examination was conducted in less than acceptable conditions due to the limited access to the aircraft. *(See photograph to follow below)*. The investigation by AMT investigators regarding to aircraft will be limited and also will rely on damage photographs taken by other agencies and investigators. All photographs used by AMT investigators are contained within this report. Damage to the floatplane was limited to the starboard float being separated from the struts, some damage to the engine cowling on the starboard side, damage to the starboard wing tip, and damage to each of the three propeller blades. *See photographs attached hereto tab #9*.

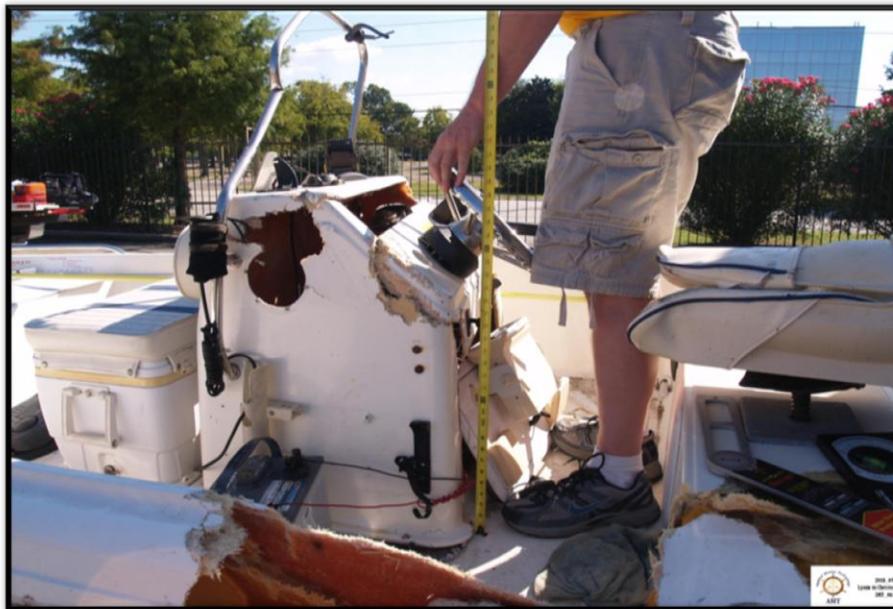
Investigators of AMT reviewed the Autopsy Report by the Lafourche Parish Coroner's Office (*attached hereto, tab #6*), for the purpose of identifying what caused the wounds on the victim's body, which shows extensive lacerations to the victims back. His left lateral back area shows severe lacerating injury with exposure of the chest contents. Several other lacerations are seen on the lateral left flank with incised areas measuring approximately 5x2cm and 3 m in length. Left upper leg shows laceration measuring approximately 10x1 cm. Some abrasions are seen on the left lower leg. The left femur shows fracture.

From the standing position of Mr. Lyons at the console of his boat, the wounds on his body match up with the starboard pontoon tip striking him in the left lower back and upper back, causing his body to be jammed against the steering wheel and console, and then lifted out of the boat, into the water. Evidence on the boat suggests to AMT investigators that the travel path of the floatplane's starboard pontoon would have passed through Mr. Lyons' standing position behind the steering console of his vessel as indicated by the directional bend in the operator's seat as well as the steering console which is representative of the direction of impact damage. (*See diagram #2018-09-4 by AMT attached hereto, tab #5*). (*Also see AMT photograph #21 and #86 attached hereto, tab #8*).
